New York State Department of Transportation

Yellow Flag NB23U4W014

BIN: 1065318

Location: Span 256 Girder G16 at Pier 256 over 3rd Avenue NB

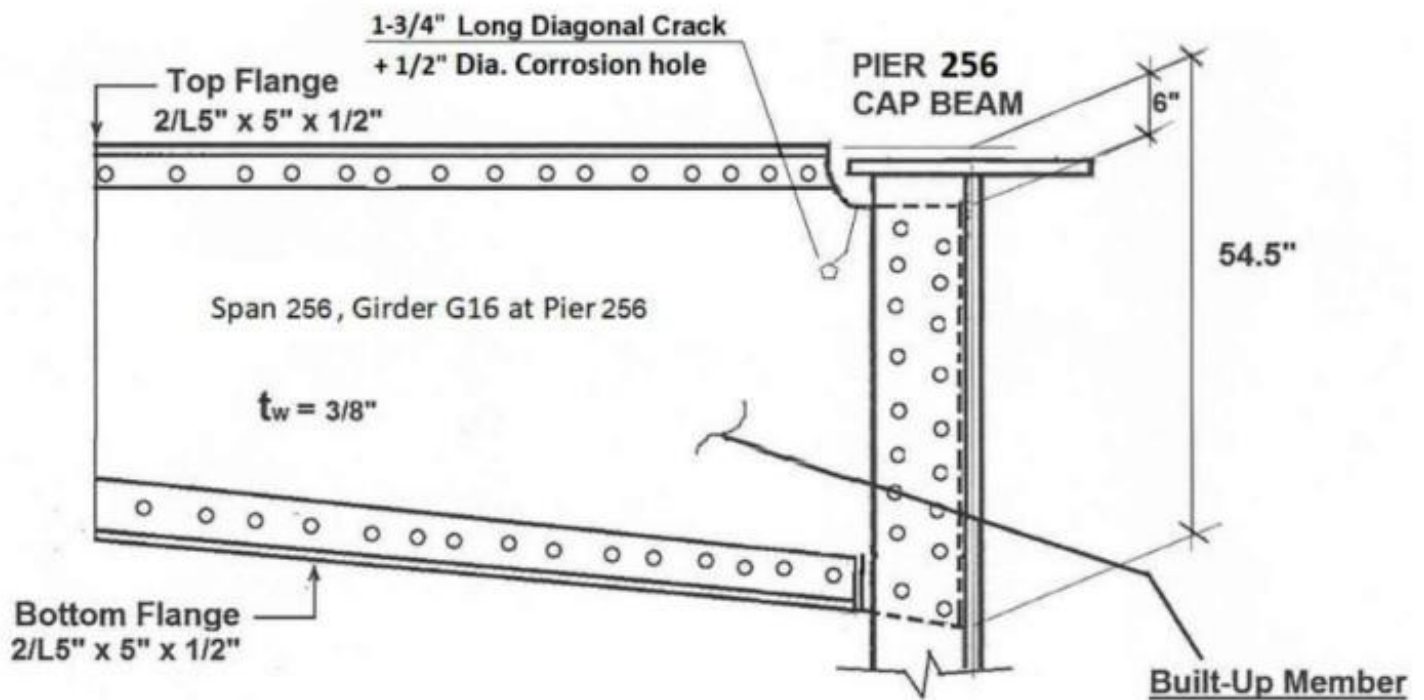
Photo Number: 2

Vary depth web: 54.5" b-tob Ls at Piers 255 and 256 and 33" at midspan.

Web thickness = 3/8"

Bottom and Top Flanges are two equal leg angles L 5" x 5" x 1/2"

SKETCH FOR YELLOW # NB23U4W014
SPAN 256, GIRDER G16 AT PIER 256
(LOOKING LEFT)
N.T.S

Attachment Description: Flag Condition Sketch

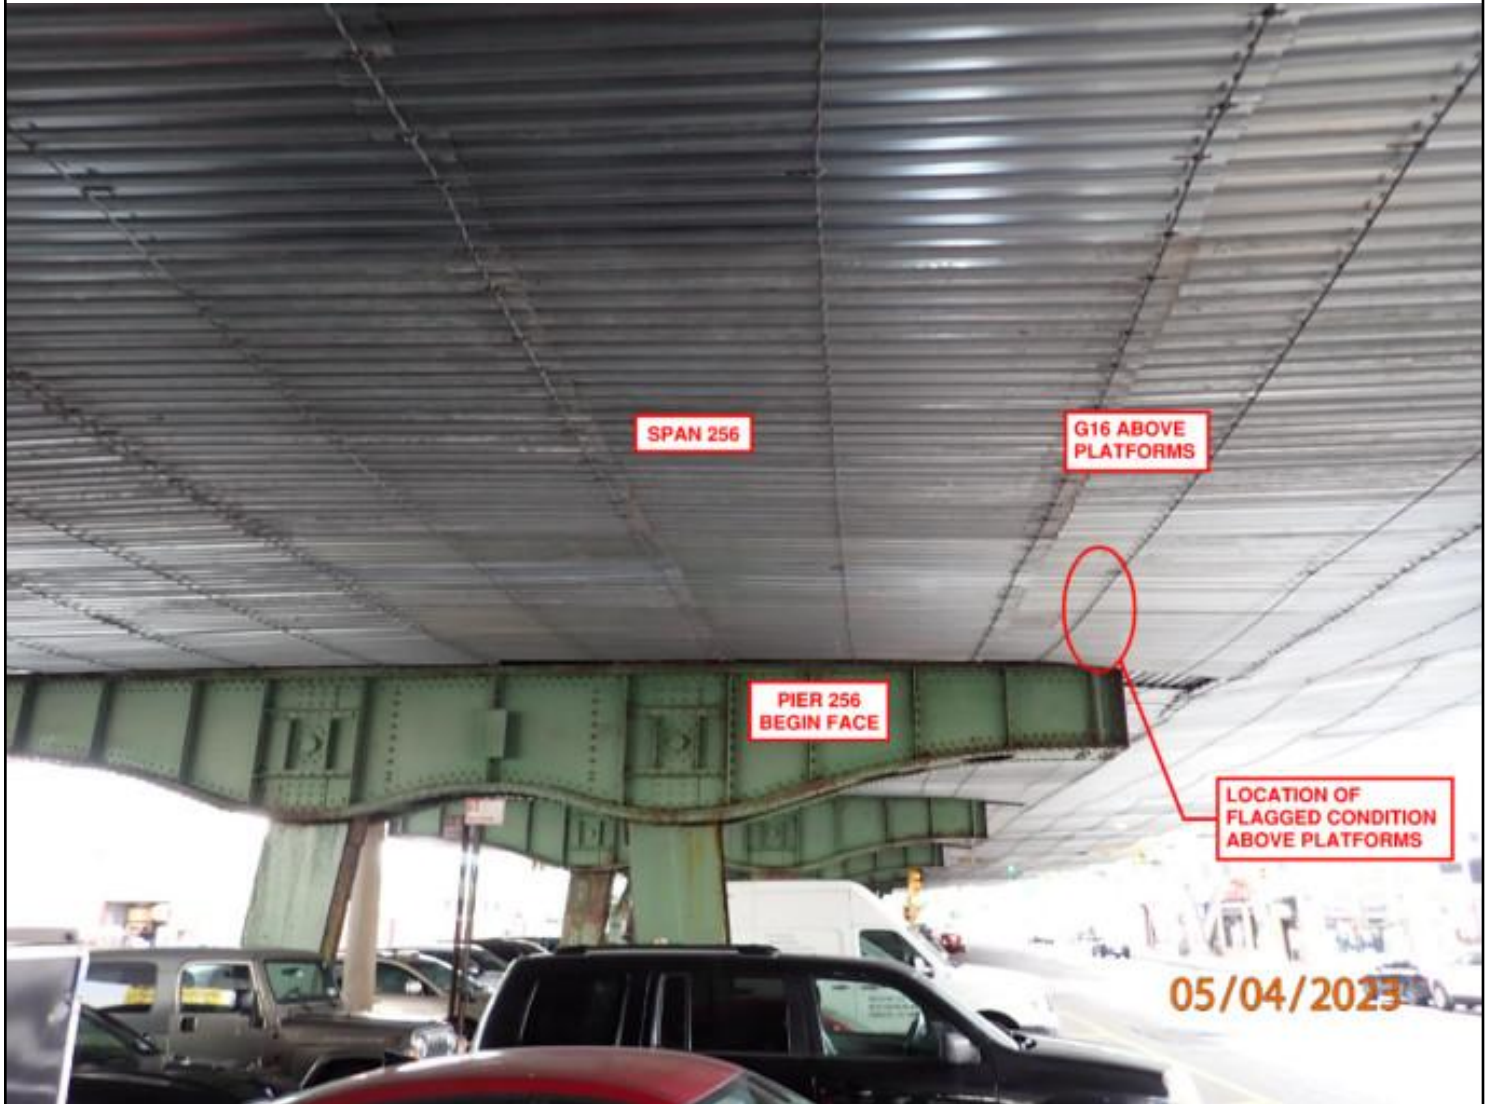
Photo Number: 3

Attachment Description: General View of Flag Location. Looking End

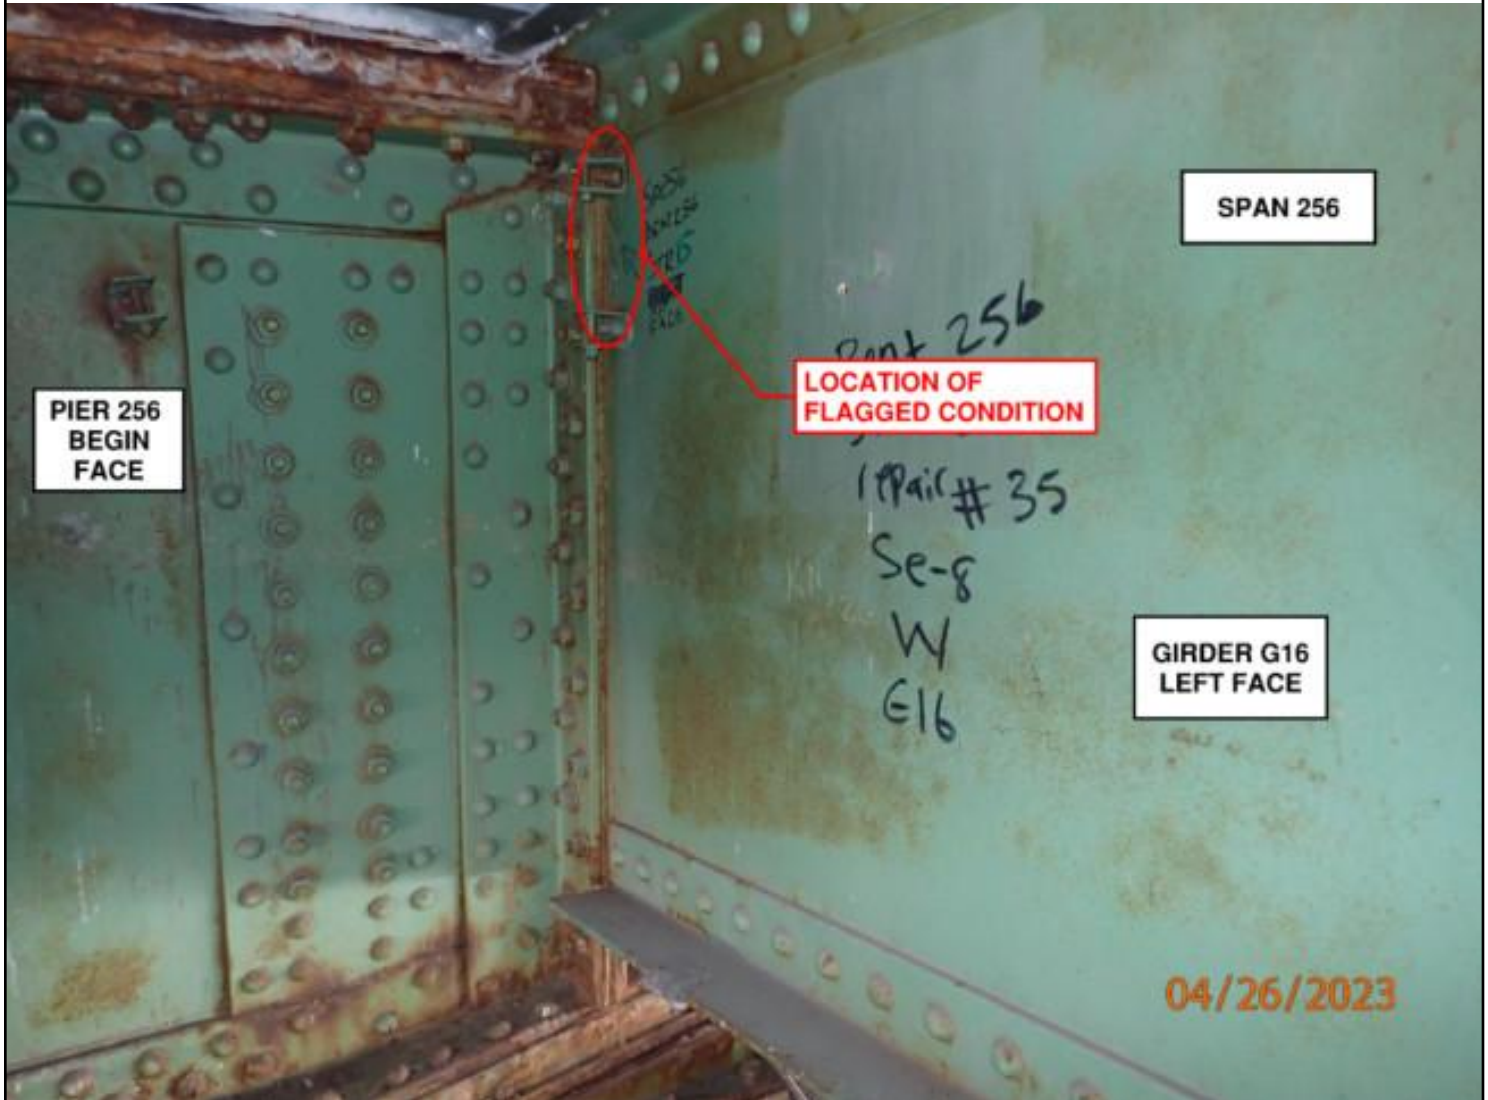
Photo Number: 4

Attachment Description: General View of the Girder End with flagged condition. Looking End-Right.

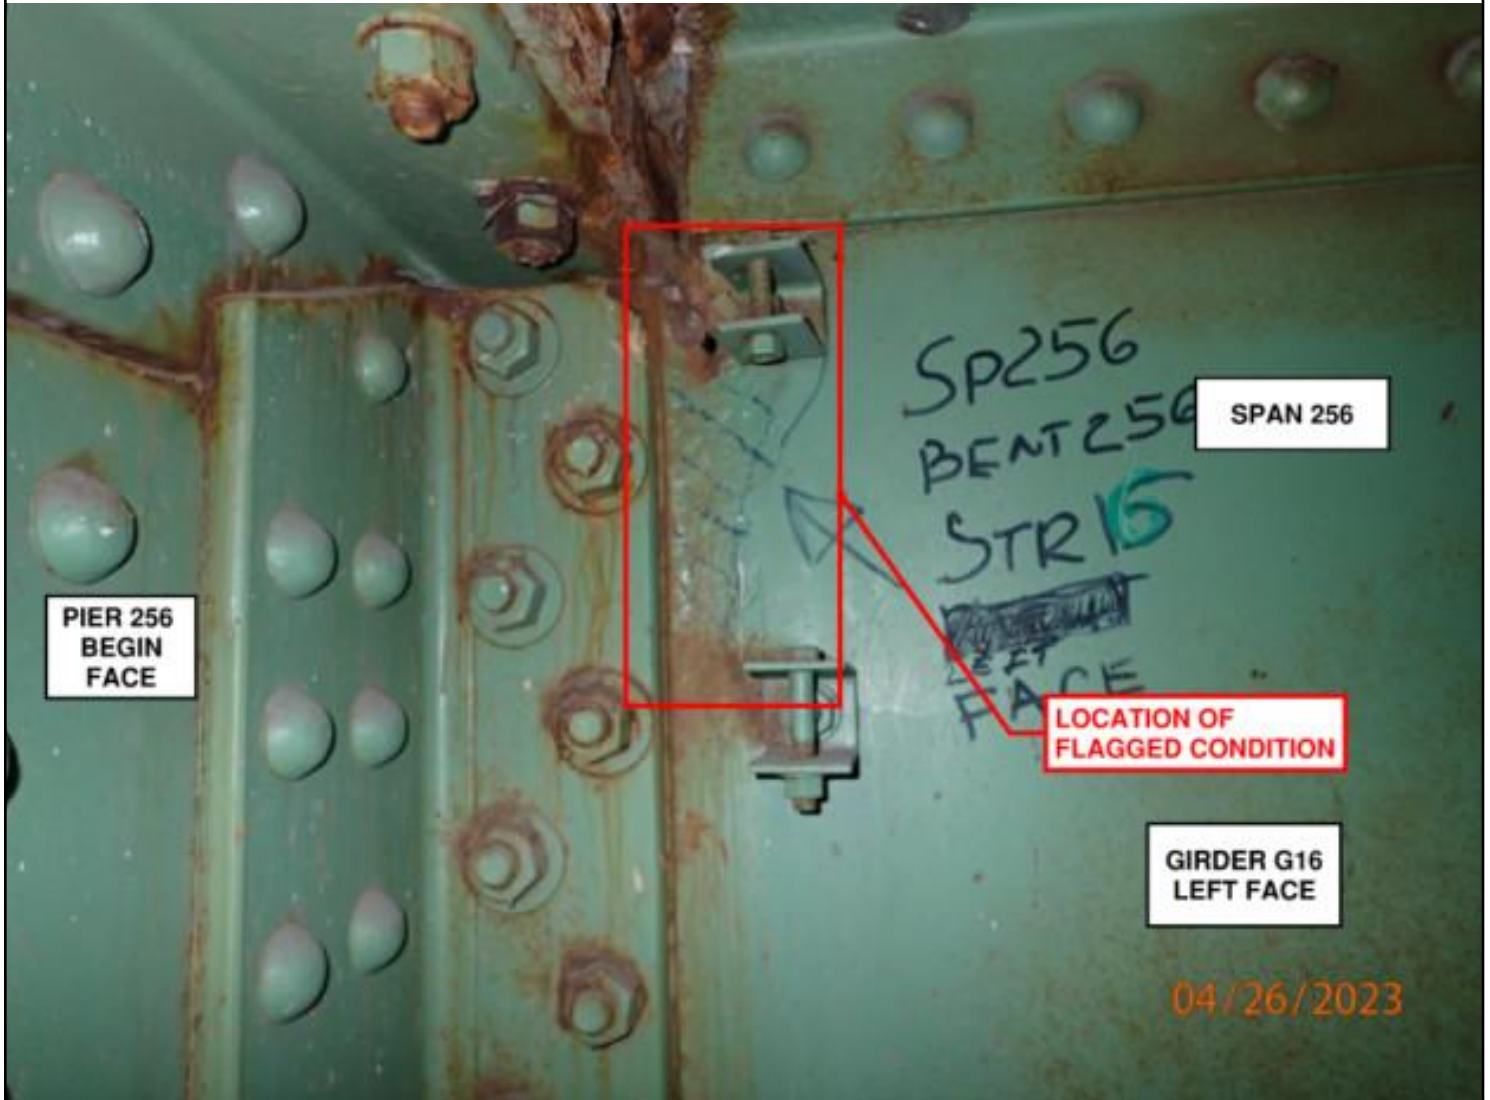
Photo Number: 5

Description: The web of the girder at the upper cope has a 1-3/4" long diagonal crack that extends into a 1/2" diameter corrosion hole. The surrounded web area of 11" H x 3" W has up to 3/16" deep section loss.

There has been no significant change since previous inspection.

Attachment Description: Close up view of flagged condition. 1-3/4" L crack with a 1/2" dia. corrosion hole with up to 3/16" SL in surrounding area of 11" H x 3" W. Looking Right.

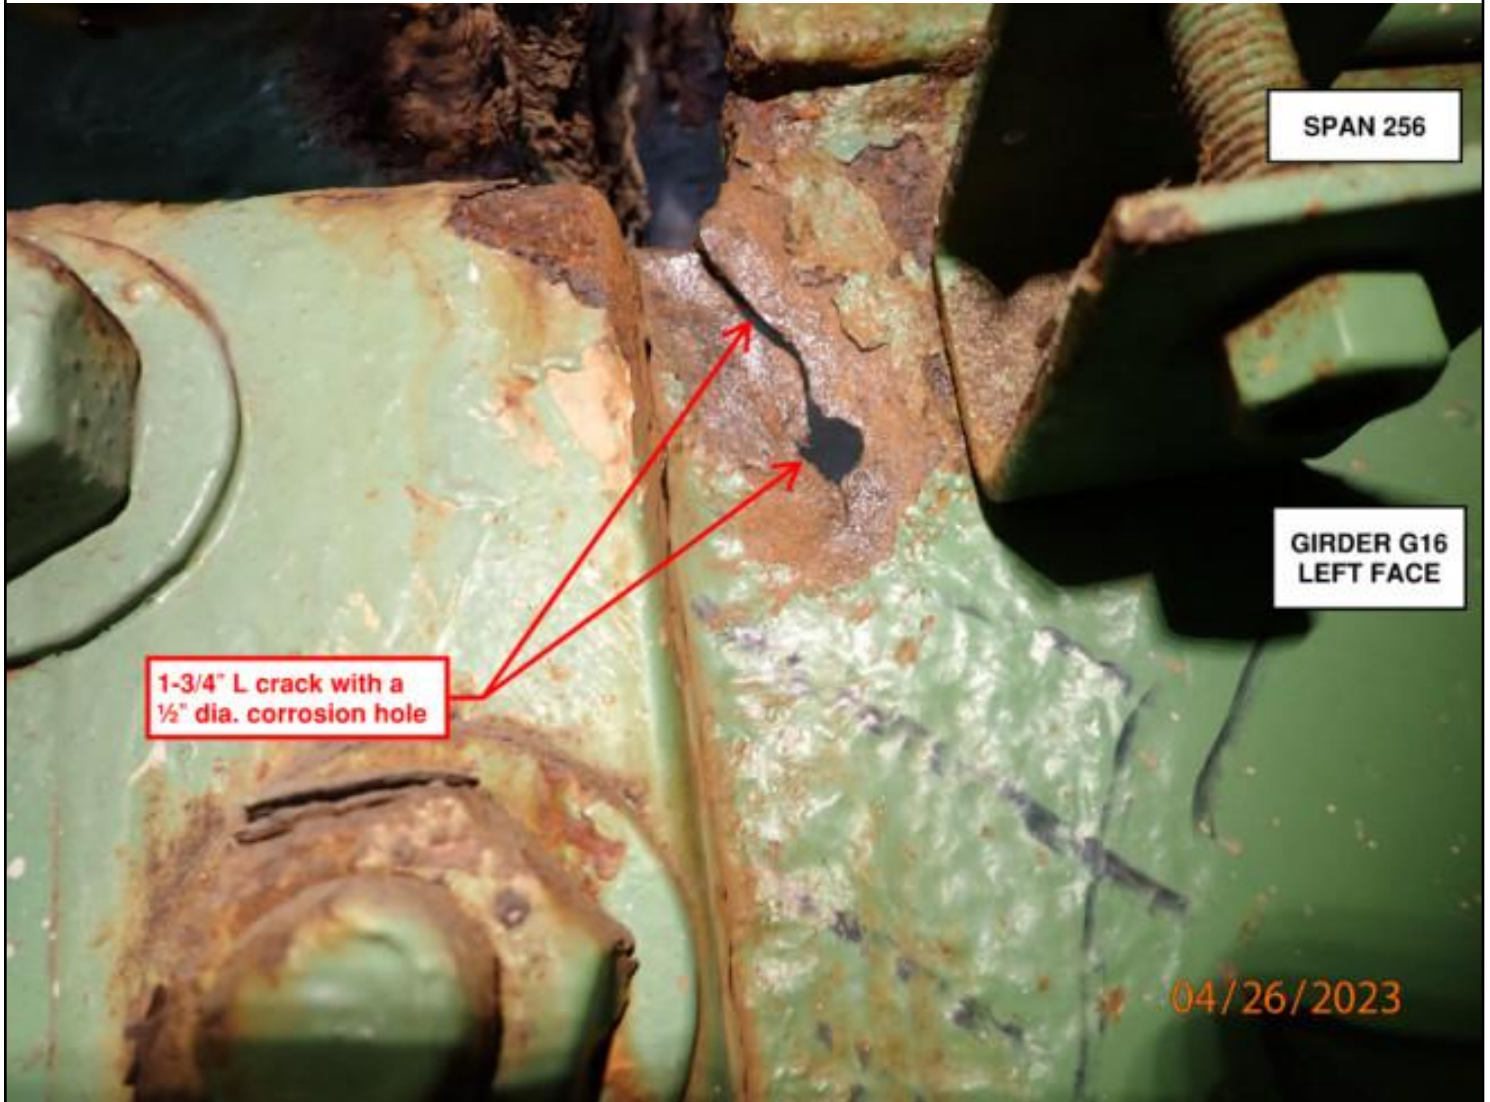
Photo Number: 6

Attachment Description: Close up view of flagged condition. 1-3/4" L crack with a 1/2" dia. corrosion hole at upper cope of Girder web. Looking Right.
